BMW 5: 1DJS509

Limited Technical Inspection

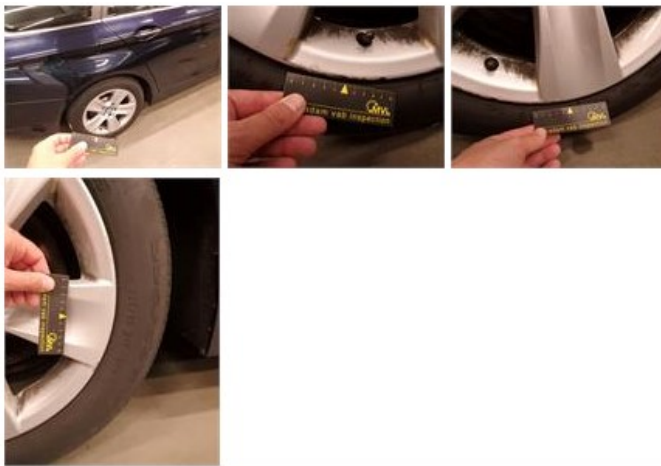
Seat cover R L, Dirty, Acceptable	0,00
<i>No pictures to display</i>	
Alloy rim R R, Scratch(es), LI - Repair and paint (complete)	95,00

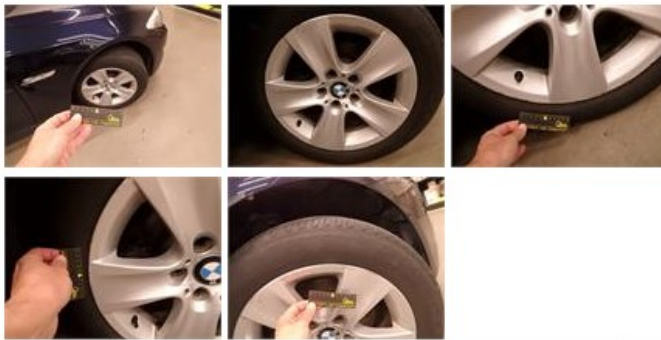
Wing R R, Bump(s), Acceptable	0,00
<i>No pictures to display</i>	
Alloy rim F R, Scratch(es), LI - Repair and paint (complete)	95,00
