**OPEL Astra: 1FEY454**

**Limited Technical Inspection**

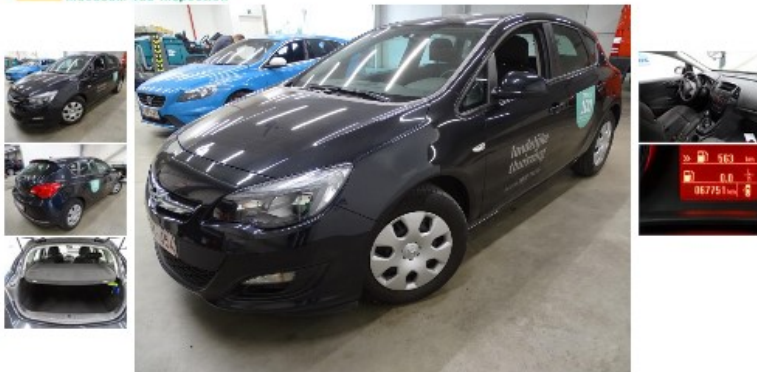
Vinnnumber:	<b>W0LPC6DA7D1115222</b>	Versionname:	<b>ASTRA BER ecoFLEX Essentia S&amp;S 95PK</b>
First Registrationdate:	<b>11/06/2013</b>	Fiscalpower:	
Expertise Mileage:	<b>67751</b>	Power Kw:	<b>70</b>
Bodytype:	<b>Hatchback</b>	Body color:	<b>Black</b>
Gearbox:	<b>MAN 5 VIT</b>	Paint type:	<b>Metalic</b>
Transmission:	<b>Front</b>	Rims summer:	<b>Steel</b>
Fueltype:	<b>Diesel</b>	Oil level:	<b>OK</b>
Battery functioning:	<b>Yes</b>	Parking lot:	<b>4304</b>
Number of doors:	<b>5</b>		
Number of seats:	<b>5</b>		
Number head rests:	<b>5</b>		
Rims summer:	<b>Steel</b>		
Category:	<b>Passenger Car</b>		
Oil level:	<b>OK</b>
