**RENAULT Kangoo Express: MC9535**

**Limited Technical Inspection**

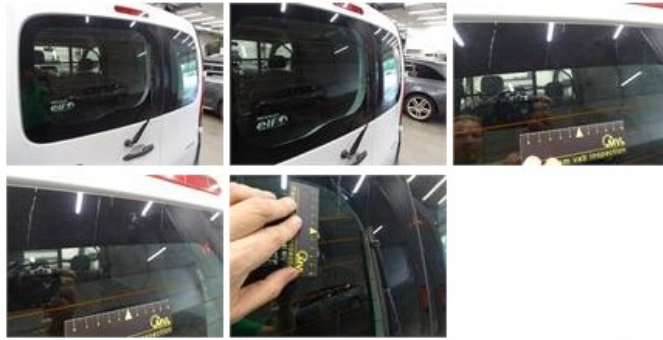
Bonnet, Bump(s), Acceptable	0,00
<i>No pictures to display</i>	
Wing R R, Bump(s) and scratch(es), Acceptable	0,00
<i>No pictures to display</i>	
Seat cover F L, Worn, Acceptable	0,00
<i>No pictures to display</i>	
Door R R, Bump(s) and scratch(es), Acceptable	0,00
<i>No pictures to display</i>	
Rear window, Scratch(es), E - Replace	307,50

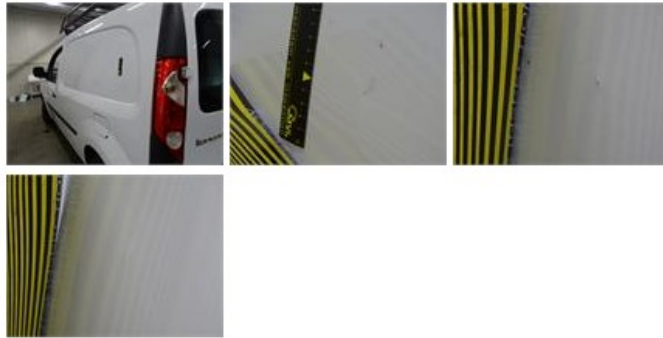
Headlight L, Stain, Acceptable	0,00
<i>No pictures to display</i>	
Front bumper, Scratch(es), Acceptable	0,00
<i>No pictures to display</i>	
Bumper R, Scratch(es), Acceptable	0,00
<i>No pictures to display</i>	
Door F L, Bump(s) and scratch(es), Acceptable	0,00
<i>No pictures to display</i>	
Wing R L, Bump(s), LI - Repair and paint (complete)	231,15
