SKODA Superb: 1HBT762

Limited Technical Inspection

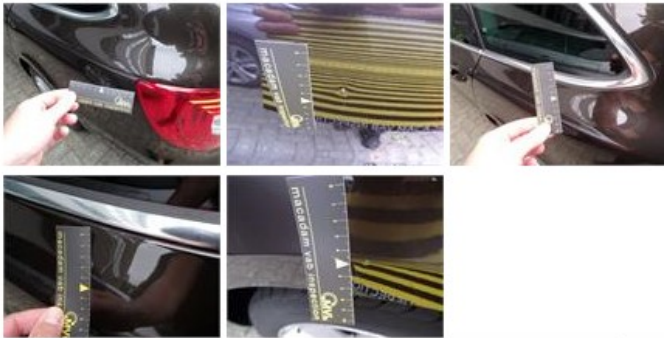
<i>No pictures to display</i>		
Alloy rim R R, Scratch(es), Acceptable		0,00
<i>No pictures to display</i>		
Wing R L, Bump(s), PDR - Knock out without painting		63,00

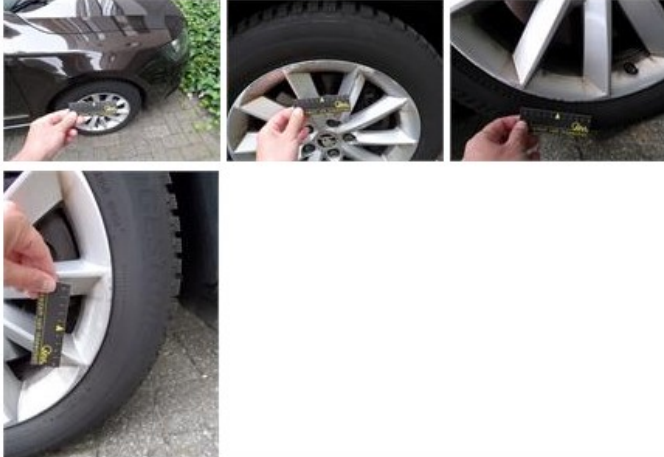
Alloy rim F R, Scratch(es), LI - Repair and paint (complete)		95,00
