VOLKSWAGEN Passat: 1GSV592			
Vinnnumber:	<b>WVWZZZ3CZEE106896</b>	Versionname:	<b>PASSAT VAR Comfortline</b>
First Registrationdate:	<b>18/04/2014</b>	Fiscalpower:	<b>136PK</b>
Expertise Mileage:	<b>174925</b>	Power Kw:	<b>100</b>
Bodytype:	<b>Break</b>	Body color:	<b>Dark Brown</b>
Gearbox:	<b>MAN 6 VIT</b>	Paint type:	<b>Metalic</b>
Transmission:	<b>Front</b>	Rims summer:	<b>Aluminium</b>
Fueltype:	<b>Diesel</b>	Oil level:	<b>OK</b>
Battery functioning:	<b>Yes</b>	Parking lot:	<b>2303</b>
Number of doors:	<b>5</b>		
Number of seats:	<b>5</b>		
Number head rests:	<b>5</b>		
Rims summer:	<b>Aluminium</b>		
Category:	<b>Passenger Car</b>		
Oil level:	<b>OK</b>		
Registration Certificate Car (BE):	<b>Yes</b>

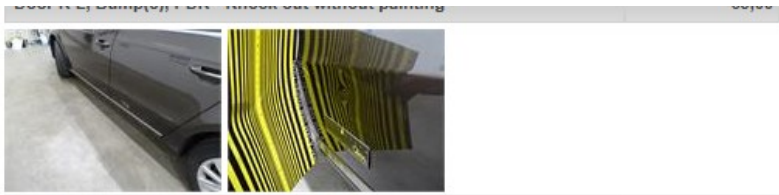
Tailgate, Scratch(es), Acceptable	0,00
<i>No pictures to display</i>	
Roof, Scratch(es), Acceptable	0,00
<i>No pictures to display</i>	
Door R L, Bump(s), PDR - Knock out without painting	63,00
