**VOLVO V60: 1HAZ695**

**Limited Technical Inspection**

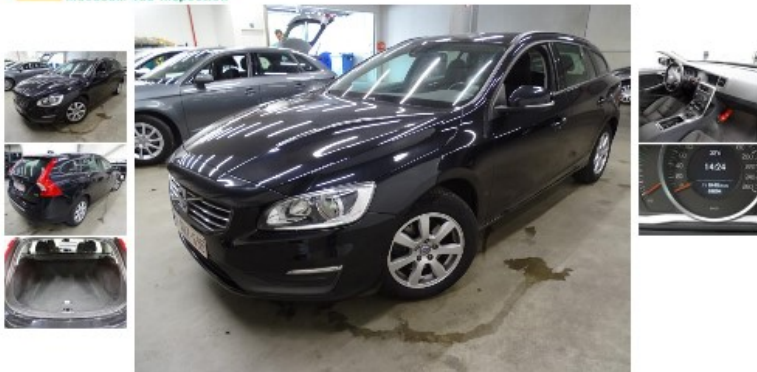
Vinnnumber:	<b>YV1FW8481E1213952</b>	Versionname:	<b>V60 BRE D2 Kinetic 115PK</b>
First Registrationdate:	<b>6/06/2014</b>	Fiscalpower:	
Expertise Mileage:	<b>69893</b>	Power Kw:	<b>84</b>
Bodytype:	<b>Break</b>	Body color:	<b>Black</b>
Gearbox:	<b>MAN 6 VIT</b>	Paint type:	<b>Metalic</b>
Transmission:	<b>Front</b>	Rims summer:	<b>Aluminium</b>
Fueltype:	<b>Diesel</b>	Oil level:	<b>OK</b>
Battery functioning:	<b>Yes</b>	Parking lot:	<b>2514</b>
Number of doors:	<b>5</b>		
Number of seats:	<b>5</b>		
Number head rests:	<b>5</b>		
Rims summer:	<b>Aluminium</b>		
Category:	<b>Passenger Car</b>		
Oil level:	<b>OK</b>		
Registration Certificate Car (BE):	<b>Yes</b>
