BMW 5: 1HFB600			
Vinnnumber:	WBA5J31000D073832	Versionname:	5 TOURING 520d 163PK
First Registrationdate:	4/07/2014	Fiscalpower:	
Expertise Mileage:	113348	Power Kw:	120
Bodytype:	Break	Body color:	White
Gearbox:	MAN 6 VIT	Paint type:	Metalic
Transmission:		Rims summer:	Aluminium
Fueltype:	Diesel	Oil level:	OK
Battery functioning:	Yes	Parking lot:	4230
Number of doors:	5		
Number of seats:	5		
Number head rests:	5		
Rims summer:	Aluminium		
Category:	Passenger Car		
Oil level:	OK		
Registration Certificate Car (BE):	Yes

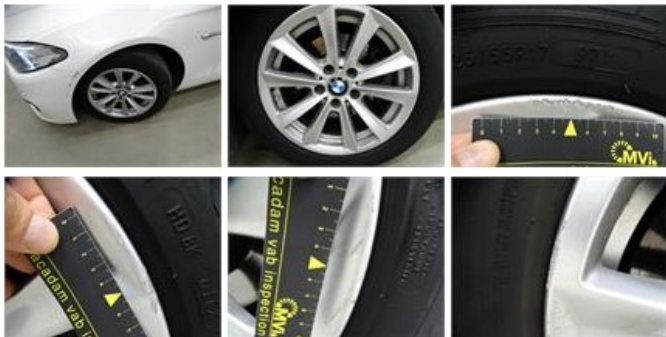
Assistance equipment			
Repair kit	Yes	Compressor	Yes
Total cost ex VAT			888,32
Alloy rim F L, Scratch(es), LI - Repair and paint (complete)			95,00
