RENAULT Grand Scenic: 1DMQ364			
Vinnnumber:	VF1JZ14A647316200	Versionname:	GR.SCENIC Energ.Business 5pl.FAP 110PK
First Registrationdate:	25/06/2012	Fiscalpower:	
Expertise Mileage:	164762	Power Kw:	81
Bodytype:	Hatchback	Body color:	Black
Gearbox:	MAN 6 VIT	Paint type:	Metalic
Transmission:		Rims summer:	Aluminium
Fueltype:	Diesel	Oil level:	OK
Battery functioning:	Yes	Parking lot:	4709
Number of doors:	5		
Number of seats:	5		
Number head rests:	5		
Rims summer:	Aluminium		
Category:	Passenger Car		
Oil level:	OK

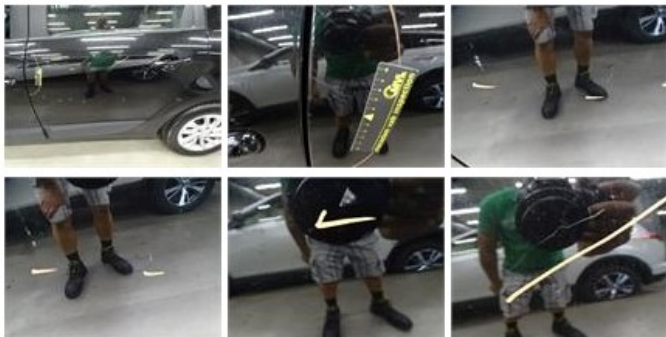
Assistance equipment			
Spare wheel	Yes	Jack	Yes
Total cost ex VAT	831,83		
Wing R L, Scratch(es), Acceptable	0,00		
<i>No pictures to display</i>			
Door R L, Scratch(es), LI - Repair and paint (complete)	318,35

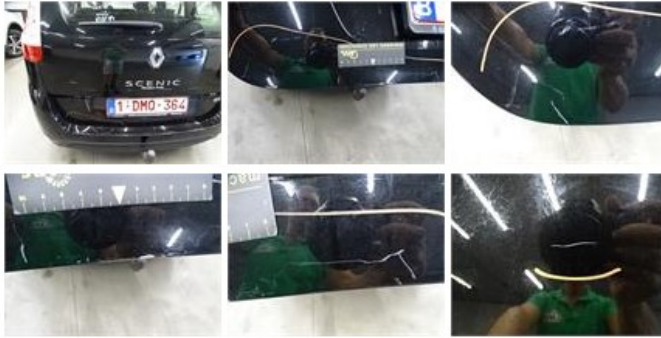
Door F R, Scratch(es), Acceptable	0,00
<i>No pictures to display</i>	
Wing R R, Scratch(es), Acceptable	0,00
<i>No pictures to display</i>	
Wing F L, Scratch(es), Acceptable	0,00
<i>No pictures to display</i>	
Rear window, Scratch(es), Acceptable	0,00
<i>No pictures to display</i>	
Tailgate, Scratch(es), LI - Repair and paint (complete)	301,68

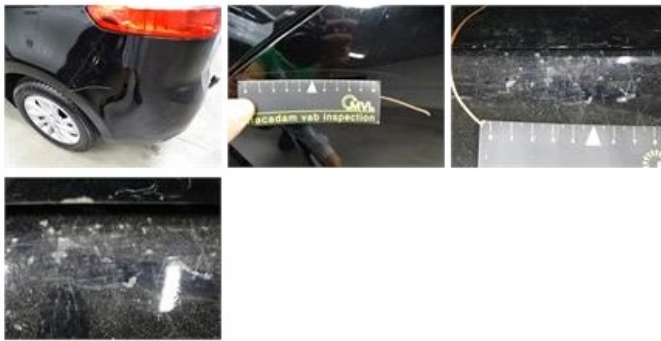
Bumper R, Scratch(es), LI - Repair and paint (complete)	211,80
---	--------
