**BMW 316d: 1GQG108**

**Limited Technical Inspection**

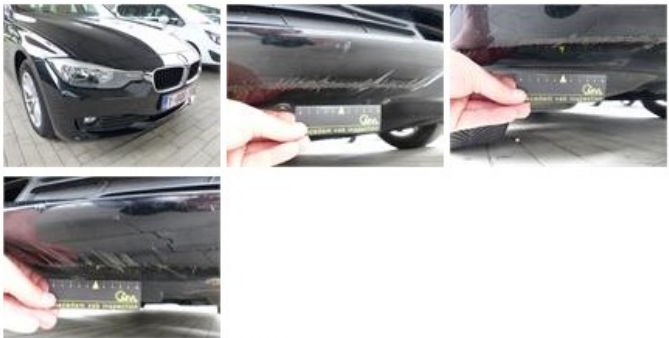
Door R R, Scratch(es), Acceptable	0,00
<i>No pictures to display</i>	
Door F R, Scratch(es), Acceptable	0,00
<i>No pictures to display</i>	
Bumper R, Scratch(es), Acceptable	0,00
<i>No pictures to display</i>	
Rearview mirror housing L, Scratch(es), Acceptable	0,00
<i>No pictures to display</i>	
Front bumper, Scratch(es), LI - Repair and paint (complete)	211,80
