**FORD Focus: 1FTV320**

**Limited Technical Inspection**

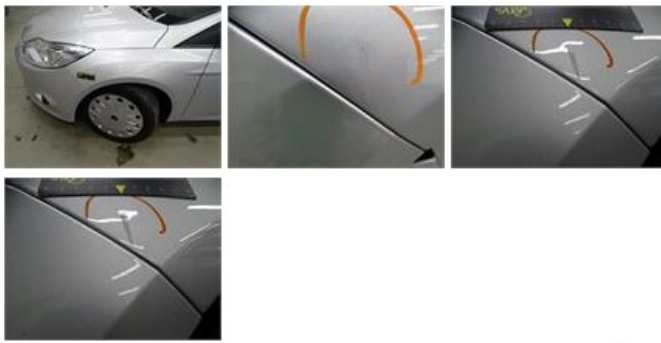
Total cost ex VAT	538,53
Wing R L, Scratch(es), Acceptable	0,00
<i>No pictures to display</i>	
Wing R R, Scratch(es), Acceptable	0,00
<i>No pictures to display</i>	
Tailgate, Scratch(es), Acceptable	0,00
<i>No pictures to display</i>	
Wheel cover R R, Scratch(es), Acceptable	0,00
<i>No pictures to display</i>	
Wing F L, Bump(s) and scratch(es), LI - Repair and paint (complete)	220,18

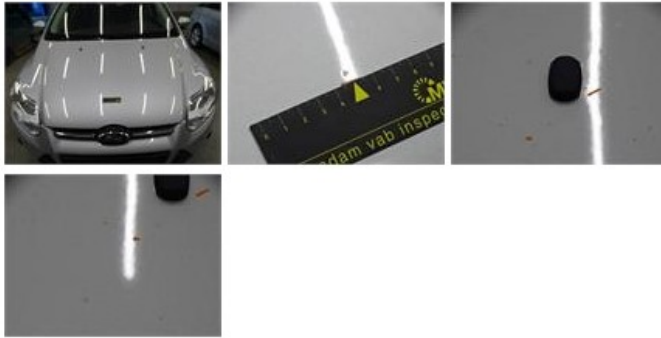
Bonnet, Bad repair, Acceptable 0,00
