## VOLVO V70: 1GIL243

## Limited Technical Inspection

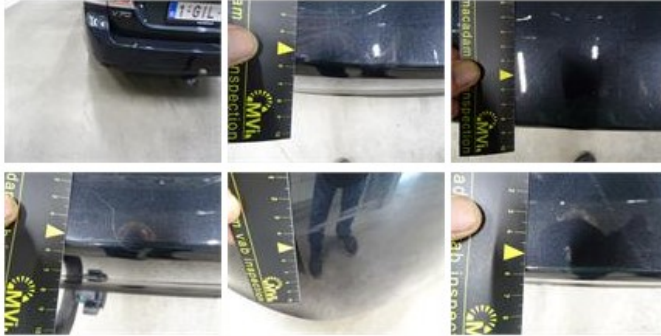
Door F L, Scratch(es), Acceptable	0,00
<i>No pictures to display</i>	
Rear window, Scratch(es), Acceptable	0,00
<i>No pictures to display</i>	
Wing R R, Scratch(es), Acceptable	0,00
<i>No pictures to display</i>	
Door panel R L, Damaged, Acceptable	0,00
<i>No pictures to display</i>	
Wing F R, Repaired, Acceptable	0,00
<i>No pictures to display</i>	
Bumper R, Scratch(es), LI - Repair and paint (complete)	254,16
