**AUDI A6: 1HGB573**

**Limited Technical Inspection**

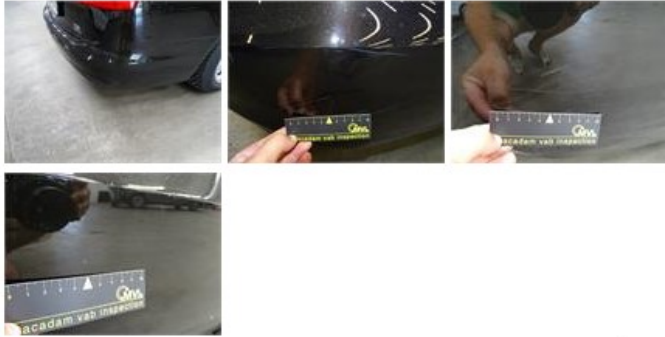
Interior, Dirty, Acceptable	0,00
<i>No pictures to display</i>	
Alloy rim F L, Scratch(es), Acceptable	0,00
<i>No pictures to display</i>	
Bonnet, Scratch(es), Acceptable	0,00
<i>No pictures to display</i>	
Bumper corner R R, Scratch(es), It - Spot repair	115,56
