<b>BMW 3: 1FEY450</b>			
Vinnumber:	<b>WBA3K910X0F930542</b>	Versionname:	<b>3 TOURING 316d 116PK</b>
First Registrationdate:	<b>11/06/2013</b>	Fiscalpower:	
Expertise Mileage:	<b>98711</b>	Power Kw:	<b>85</b>
Bodytype:	<b>Break</b>	Body color:	<b>Dark Grey</b>
Gearbox:	<b>MAN 6 VIT</b>	Paint type:	<b>Metalic</b>
Transmission:	<b>Back</b>	Rims summer:	<b>Aluminium</b>
Fueltype:	<b>Diesel</b>	Oil level:	<b>OK</b>
Battery functioning:	<b>Yes</b>	Parking lot:	<b>2805</b>
Number of doors:	<b>5</b>		
Number of seats:	<b>5</b>		
Number head rests:	<b>5</b>		
Rims summer:	<b>Aluminium</b>		
Category:	<b>Passenger Car</b>		
Oil level:	<b>OK</b>

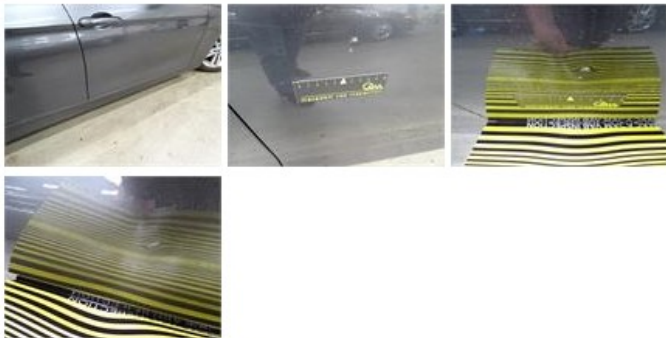
<b>Total cost ex VAT</b>	<b>926,78</b>
<b>Door F R, Bump(s) and scratch(es), LI - Repair and paint (complete)</b>	<b>318,35</b>
