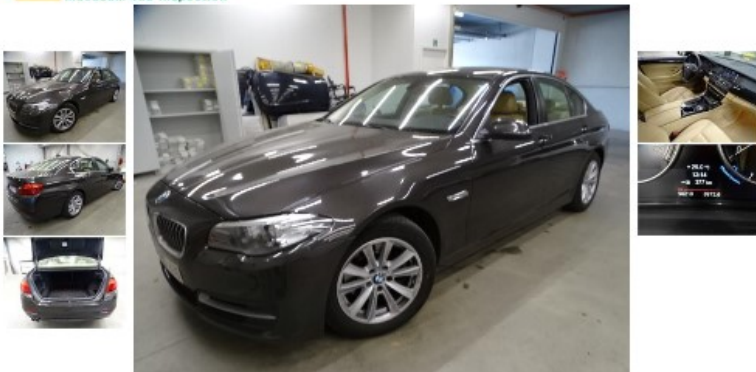
Assistance equipment			
Repair kit	Yes	Compressor	Yes
Total cost ex VAT			95,00
Bumper R, Bump(s), Acceptable			0,00
<i>No pictures to display</i>			
Alloy rim F L, Scratch(es), LI - Repair and paint (complete)			95,00
