TOYOTA GRAND PRIUS+: 1PGN641

Limited Technical Inspection

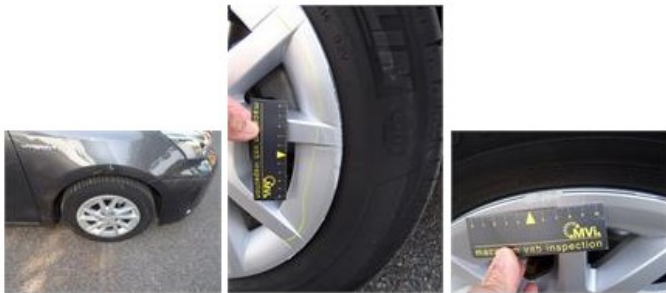
Total cost ex VAT	1257,71
Bonnet, Bump(s), Acceptable	0,00
<i>No pictures to display</i>	
Wheel cover F R, Scratch(es), E - Replace	30,00

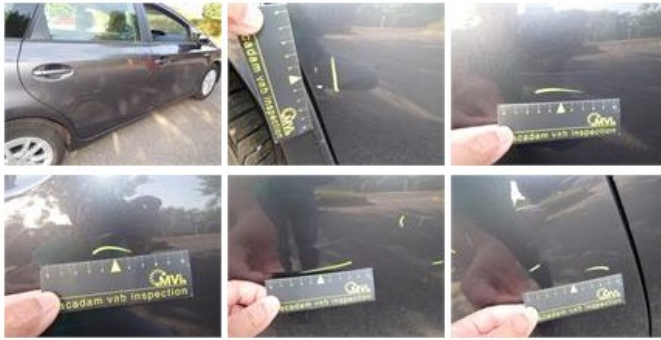
Door R R, Scratch(es), LI - Repair and paint (complete) 318,35
