VOLVO V40: 1FME880			
Vinnnumber:	YV1MV8481E2094497	Versionname:	V40 D2 Base 115PK
First Registrationdate:	14/08/2013	Fiscalpower:	
Expertise Mileage:	77104	Power Kw:	84
Bodytype:	Break	Body color:	Blue
Gearbox:	MAN 6 VIT	Paint type:	Metalic
Transmission:	Front	Rims summer:	Aluminium
Fueltype:	Diesel	Oil level:	OK
Battery functioning:	Yes	Parking lot:	3820
Number of doors:	5		
Number of seats:	5		
Number head rests:	5		
Rims summer:	Aluminium		
Category:	Passenger Car		
Oil level:	OK

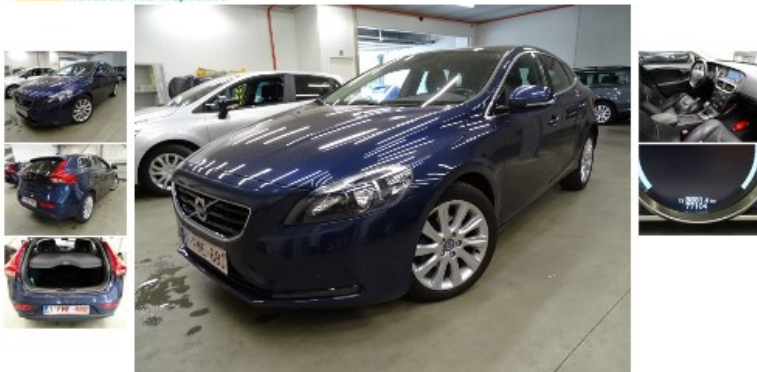
Limited Technical Inspection			
Airco functioning	OK	Battery functioning	Yes
Tires wear profile	OK	Power steering	Yes
Idle position	OK	Sound engine	OK
Engine startingtime	OK	Clutch test	OK
Exhaust gass	OK	Wiper fluid level	OK
Handbrake	OK	Transmission	OK
		Lighting	OK
		Wiperblades	OK

Degree of wear				
	205/50/17/93 W LightMetal			
Summer tyres:	Fr.L.	Pirelli: 4 mm	Fr.R.	Pirelli: 4 mm
	Re.L.	Pirelli: 4 mm	Re.R.	Pirelli: 4 mm

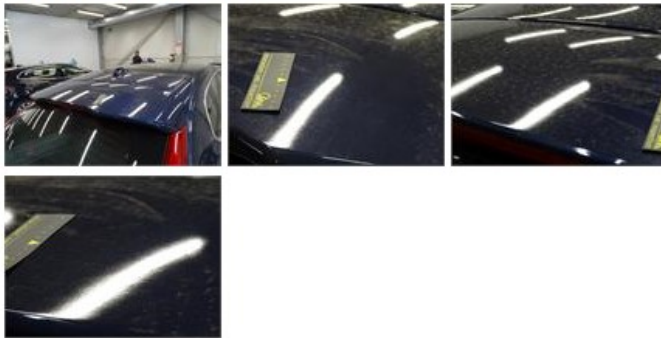
Rear spoiler, Bad repair, Paint 0,00
