RENAULT Megane: 1EYM005

Limited Technical Inspection

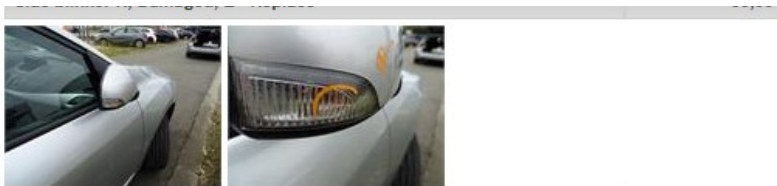
Bonnet, Bump(s), Acceptable	0,00
<i>No pictures to display</i>	
Door panel R R, Scratch(es), Acceptable	0,00
<i>No pictures to display</i>	
Door F R, Bump(s) and scratch(es), Acceptable	0,00
<i>No pictures to display</i>	
Side blinker R, Damaged, E - Replace	30,00
