MERCEDES CLA: 1HNC732

Limited Technical Inspection

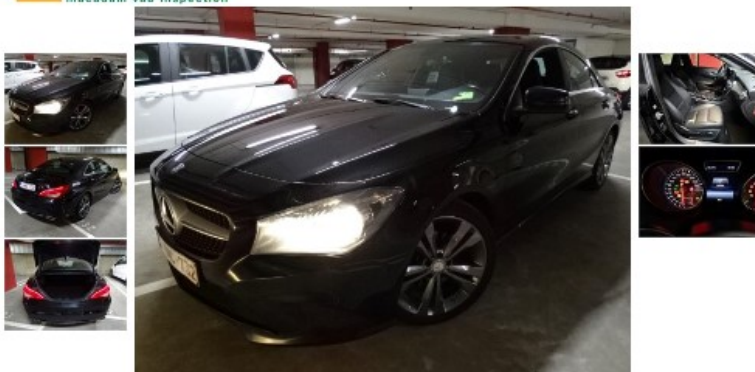
Vinnnumber:	WDD1173121N126633	Versionname:	CLA BER 180 CDI 109PK
First Registrationdate:	26/08/2014	Fiscalpower:	
Expertise Mileage:	183065	Power Kw:	80
Bodytype:		Body color:	Black
Gearbox:	MAN 6 VIT	Paint type:	Metalic
Transmission:	Back	Rims summer:	Aluminium
Fueltype:	Diesel	Oil level:	OK
Battery functioning:	Yes	Parking lot:	1407
Number of doors:	4		
Number of seats:	5		
Number head rests:	1		
Rims summer:	Aluminium		
Category:	Passenger Car		
Oil level:	OK		
Registration Certificate Car (BE):	Yes
