**RENAULT Grand Scenic: 1FCE272**

**Limited Technical Inspection**

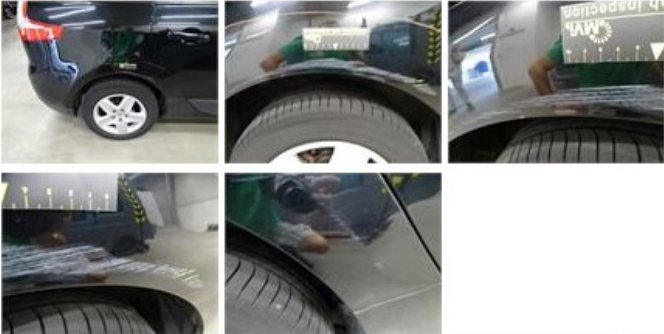
Roof, Bump(s), Acceptable	0,00
<i>No pictures to display</i>	
Door F R, Scratch(es), Acceptable	0,00
<i>No pictures to display</i>	
Wing R R, Scratch(es), LI - Repair and paint (complete)	308,20

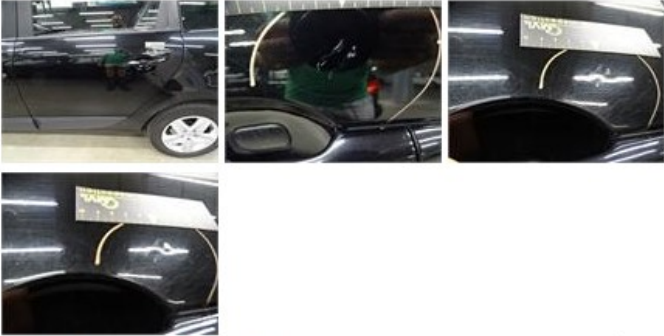
Door R L, Bump(s) and scratch(es), LI - Repair and paint (complete)	318,35

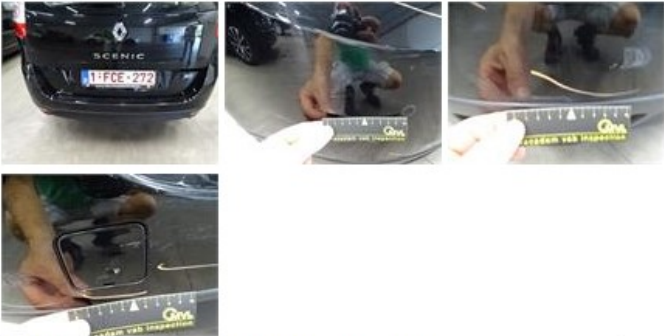
Bonnet, Stone chip(s), Acceptable	0,00
<i>No pictures to display</i>	
Bumper R, Scratch(es), LI - Repair and paint (complete)	211,80
