RENAULT Grand Scenic: 1GSD970

Limited Technical Inspection

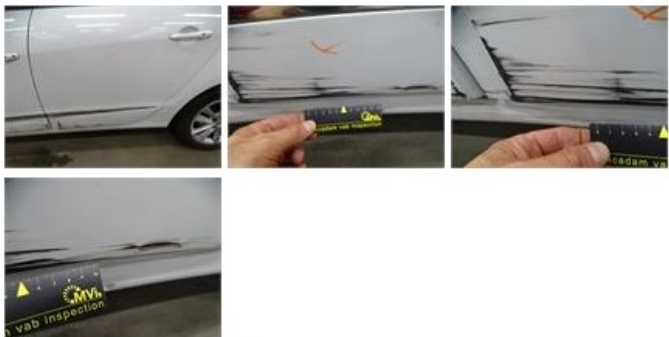
Door moulding Lower R L, Scratch(es), Smart repair 110,64

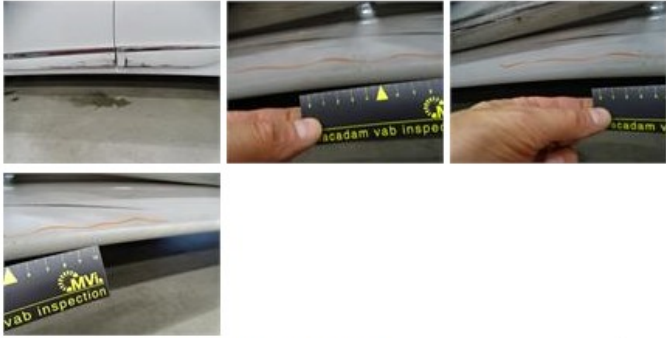
Tailgate, Scratch(es), Acceptable	0,00
<i>No pictures to display</i>	
Sill outer L, Bump(s) and scratch(es), LI - Repair and paint (complete)	310,50

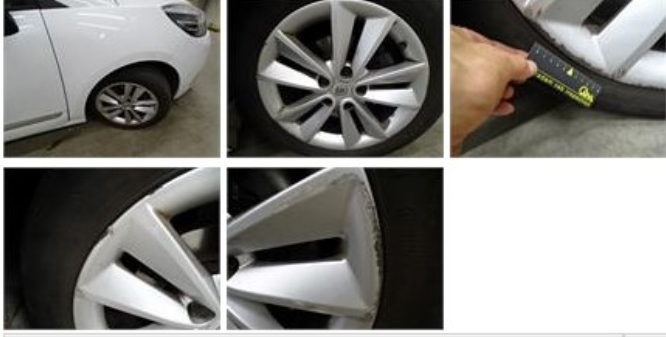
Alloy rim F R, Scratch(es), LI - Repair and paint (complete)	95,00

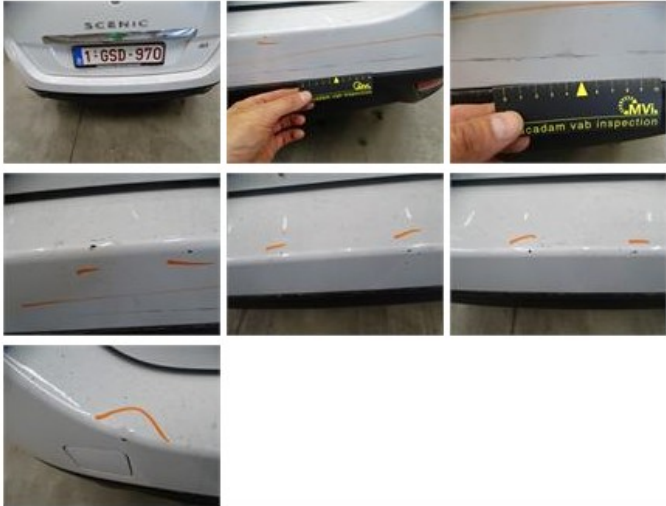
Alloy rim F L, Scratch(es), Acceptable	0,00
<i>No pictures to display</i>	
Bumper R, Bump(s) and scratch(es), LI - Repair and paint (complete)	211,80

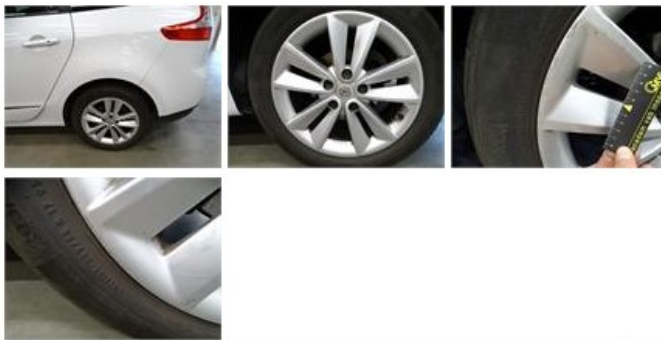
Trunk lid covering R, Scratch(es), Acceptable	0,00
<i>No pictures to display</i>	
Alloy rim R L, Scratch(es), LI - Repair and paint (complete)	95,00

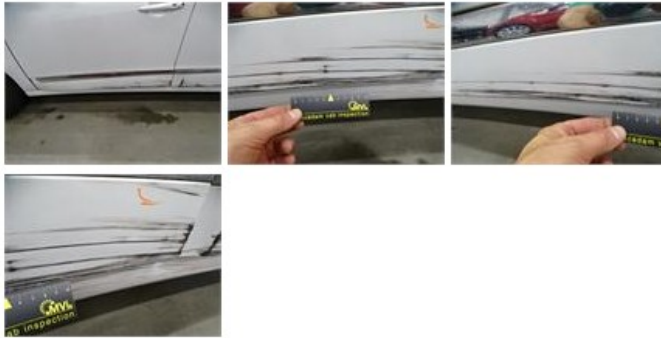
Ceiling, Stain, Acceptable	0,00
<i>No pictures to display</i>	
Internal Boot Lining L, Scratch(es), Acceptable	0,00
<i>No pictures to display</i>	
Wing F L, Scratch(es), Acceptable	0,00
<i>No pictures to display</i>	
Door moulding Lower F L, Scratch(es), Smart repair	110,64
