## VOLVO V60: 1FLC535

## Limited Technical Inspection

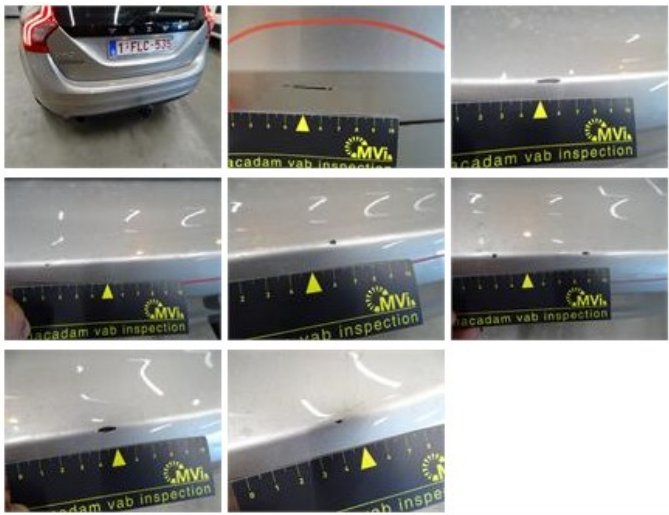
Alloy rim F R, Scratch(es), Acceptable	0,00
<i>No pictures to display</i>	
Bumper R, Scratch(es), LI - Repair and paint (complete)	211,80
