NISSAN Qashqai: 1ESB872

Limited Technical Inspection

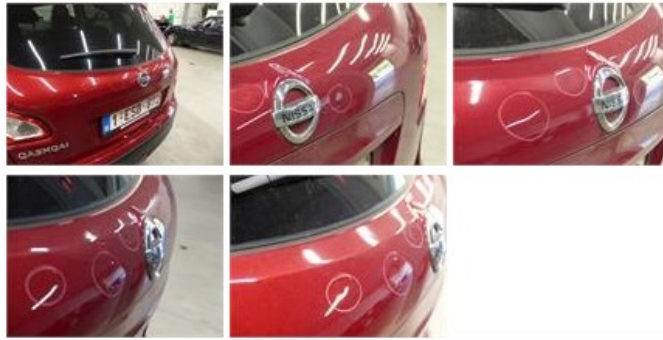
Tailgate, Dent(s), PDR - Knock out without painting	63,00
-----------------------------------------------------	-------

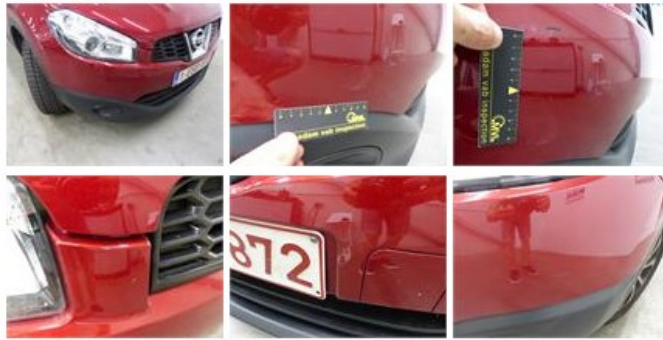
Front bumper, Scratch(es), LI - Repair and paint (complete)	211,80
-------------------------------------------------------------	--------
