BMW X1: 1FIH726			
Vinnumber:	WBAVN710X0VX05497	Versionname:	X1 sDrive18 136PK
First Registrationdate:	5/07/2013	Fiscalpower:	
Expertise Mileage:	97024	Power Kw:	100
Bodytype:	SUV	Body color:	Brown
Gearbox:	MAN 6 VIT	Paint type:	Metalic
Transmission:		Rims summer:	Aluminium
Fueltype:	Diesel	Oil level:	OK
Battery functioning:	Yes	Parking lot:	1328
Number of doors:	5		
Number of seats:	5		
Number head rests:	5		
Rims summer:	Aluminium		
Category:	Passenger Car		
Oil level:	OK

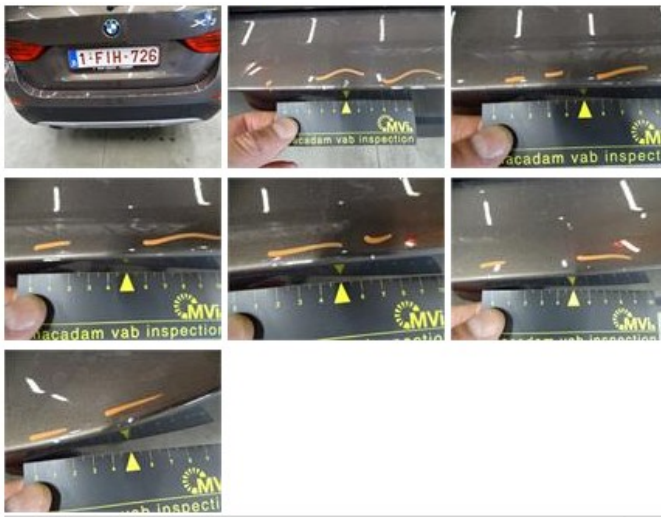
Door F L, Scratch(es), Acceptable		0,00
<i>No pictures to display</i>		
Bumper R, Scratch(es), LI - Repair and paint (complete)		211,80

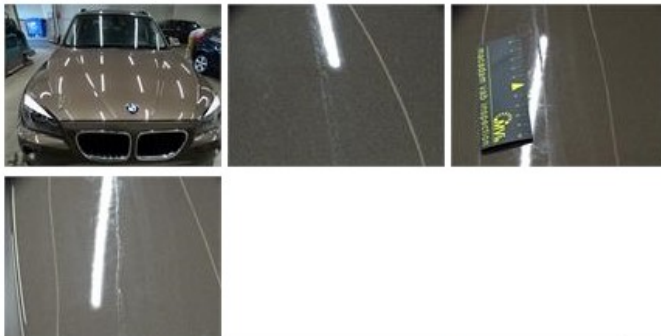
Door R L, Dent(s), Acceptable	0,00
<i>No pictures to display</i>	
Bonnet, Chemical polution, LI - Repair and paint (complete)	290,08
