VOLVO XC60: 1HHU195

Limited Technical Inspection

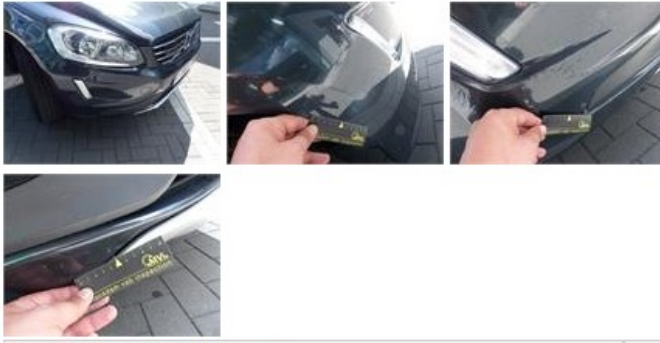
Front bumper, Dent(s) and scratch(es), Repair and paint (complete)	202,40
--	--------

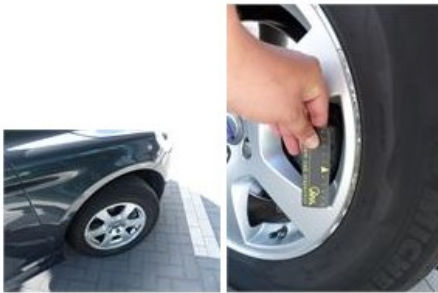
Door F L, Scratch(es), Acceptable	0,00
<i>No pictures to display</i>	
Door R L, Scratch(es), Acceptable	0,00
<i>No pictures to display</i>	
Alloy rim R R, Scratch(es), Acceptable	0,00
<i>No pictures to display</i>	
Alloy rim F R, Scratch(es), LI - Repair and paint (complete)	95,00
