PEUGEOT 508: 1FKZ208

Limited Technical Inspection

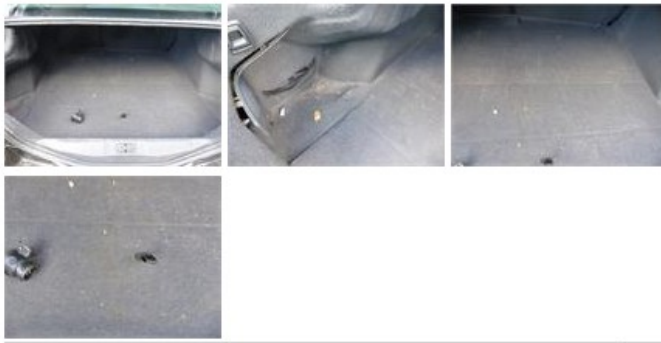
Total cost ex VAT	88,00
Alloy rim F R, Scratch(es), Acceptable	0,00
<i>No pictures to display</i>	
Door F L, Dent(s), Acceptable	0,00
<i>No pictures to display</i>	
Front bumper, Scratch(es), Acceptable	0,00
<i>No pictures to display</i>	
Backrest cover R L, Scratch(es), Acceptable	0,00
<i>No pictures to display</i>	
Boot carpet, Dirty, Cleaning	25,00
