BMW 320 D: 1FVA249

Limited Technical Inspection

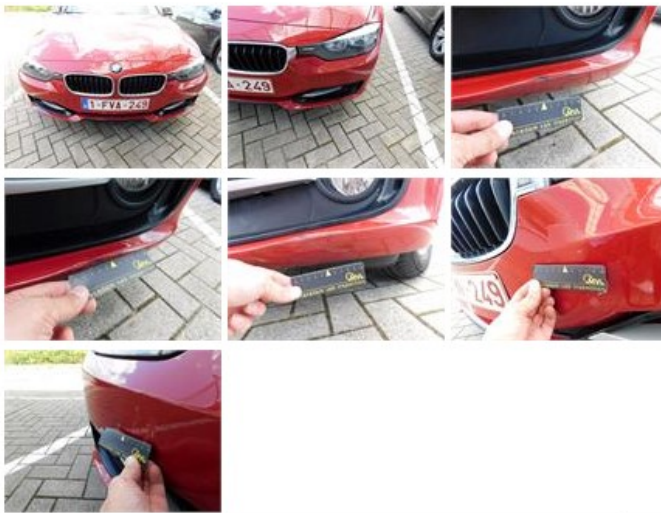
Repair kit	Yes	Compressor	Yes
Total cost ex VAT			235,80
Alloy rim F R, Scratch(es), Acceptable			0,00
<i>No pictures to display</i>			
Roof pillar L, Dent(s), Acceptable			0,00
<i>No pictures to display</i>			
Alloy rim R R, Scratch(es), Acceptable			0,00
<i>No pictures to display</i>			
Bonnet, Stone chip(s), Acceptable			0,00
<i>No pictures to display</i>			
Front bumper, Dent(s) and scratch(es), LI - Repair and paint (complete)			235,80
