KIA Sportage: 1FMR194			
Vinnnumber:	U5YPC815ADL360195	Versionname:	SPORTAGE 2WD Sense+ ISG EcoDyn.115PK
First Registrationdate:	21/08/2013	Fiscalpower:	
Expertise Mileage:	97876	Power Kw:	85
Bodytype:	SUV	Body color	Dark Grey
Gearbox:	MAN 6 VIT	Paint type	Metalic
Transmission:		Rims summer	Aluminium
Fueltype:	Diesel	Oil level	OK
Battery functioning	Yes	Parking lot	2102
Number of doors	5		
Number of seats	5		
Number head rests	5		
Rims summer	Aluminium		
Category	Passenger Car		
Oil level	OK

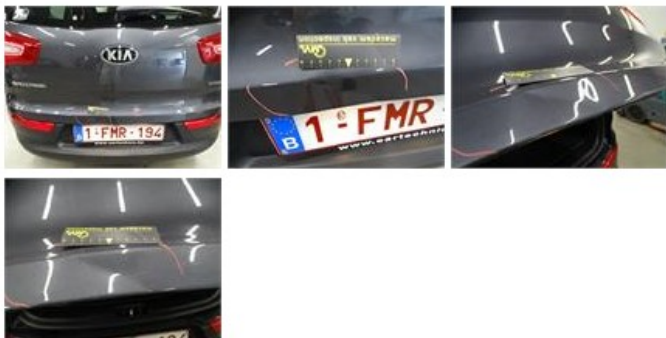
Assistance equipment			
Spare wheel	Yes	Jack	Yes
Total cost ex VAT			2514,43
Tailgate, Dent(s), LI - Repair and paint (complete)			301,68
