VOLVO V60: 1HPS382			
Vinnnumber:	<b>YV1FW8481F1233203</b>	Versionname:	<b>V60 BRE D2 Kinetic 115PK</b>
First Registrationdate:	<b>8/09/2014</b>	Fiscalpower:	
Expertise Mileage:	<b>121967</b>	Power Kw:	<b>84</b>
Bodytype:	<b>Break</b>	Body color:	<b>Dark Blue</b>
Gearbox:	<b>MAN 6 VIT</b>	Paint type:	<b>Metalic</b>
Transmission:	<b>Front</b>	Rims summer:	<b>Aluminium</b>
Fueltype:	<b>Diesel</b>	Oil level:	<b>OK</b>
Battery functioning:	<b>Yes</b>	Parking lot:	<b>2324</b>
Number of doors:	<b>5</b>		
Number of seats:	<b>5</b>		
Number head rests:	<b>5</b>		
Rims summer:	<b>Aluminium</b>		
Category:	<b>Passenger Car</b>		
Oil level:	<b>OK</b>		
Registration Certificate Car (BE):	<b>Yes</b>

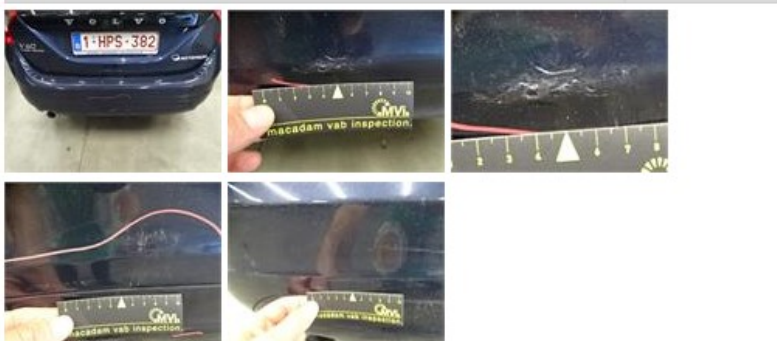
Assistance equipment			
Repair kit	<b>Yes</b>	Compressor	<b>Yes</b>
Total cost ex VAT			<b>590,36</b>
Bumper R, Dent(s), LI - Repair and paint (complete)			<b>211,80</b>
