<b>BMW 5: 1FLU157</b>			
Vinnnumber:	<b>WBAMX11080D446792</b>	Versionname:	<b>5 TOURING 520dA Start/Stop 163PK aut</b>
First Registrationdate:	<b>9/08/2013</b>	Fiscalpower:	
Expertise Mileage:	<b>141115</b>	Power Kw:	<b>120</b>
Bodytype:	<b>Break</b>	Body color:	<b>Brown</b>
Gearbox:	<b>Automatic</b>	Paint type:	<b>Metalic</b>
Transmission:		Rims summer:	<b>Aluminium</b>
Fueltype:	<b>Diesel</b>	Oil level:	<b>OK</b>
Battery functioning:	<b>Yes</b>	Parking lot:	<b>2422</b>
Number of doors:	<b>5</b>		
Number of seats:	<b>5</b>		
Number head rests:	<b>5</b>		
Rims summer:	<b>Aluminium</b>		
Category:	<b>Passenger Car</b>		
Oil level:	<b>OK</b>

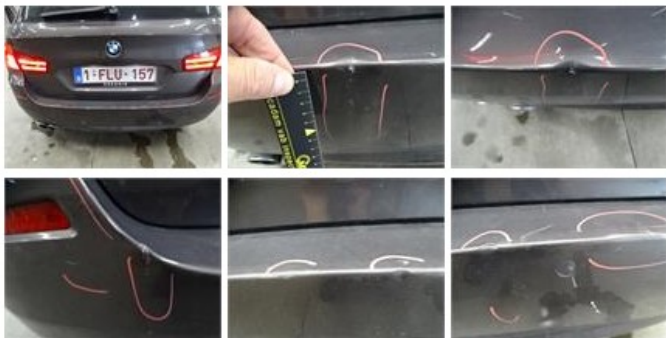
<b>Assistance equipment</b>	
Runflat	<b>Yes</b>
Total cost ex VAT	<b>1183,72</b>
Bumper R, Dent(s) and scratch(es), LI - Repair and paint (complete)	<b>254,16</b>
