AUDI Q5: JA8748

Vinnumber:	WAUZZZ8R2FA087016	Versionname:	2.0 TDI 130KW QUATTRO
First Registrationdate:	13/01/2015	Fiscalpower:	
Expertise Mileage:	180062	Power Kw:	130
Bodytype:	SUV	Body color:	White
Gearbox:	MAN 6 VIT	Paint type:	Metalic
Transmission:		Rims summer:	Aluminium
Fueltype:	Diesel	Oil level:	OK
Battery functioning:	Yes	Parking lot:	1214
Number of doors:	5		
Number of seats:	5		
Number head rests:	5		
Rims summer:	Aluminium		
Category:	Passenger Car		
Oil level:	OK

Limited Technical Inspection

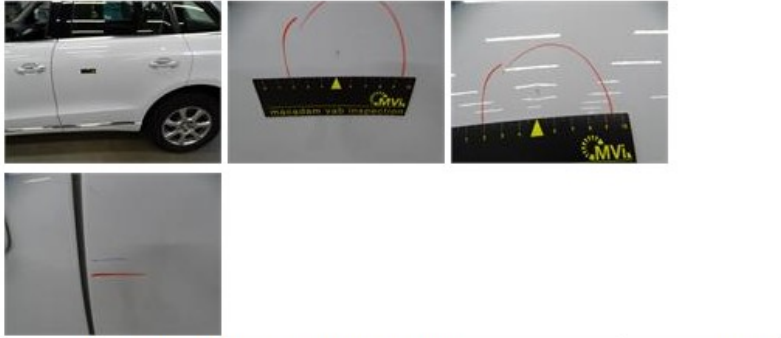
Repair kit	Yes	Compressor	Yes
Total cost ex VAT			1438,04
Door R L, Dent(s) and scratch(es), LI - Repair and paint (complete)			382,02

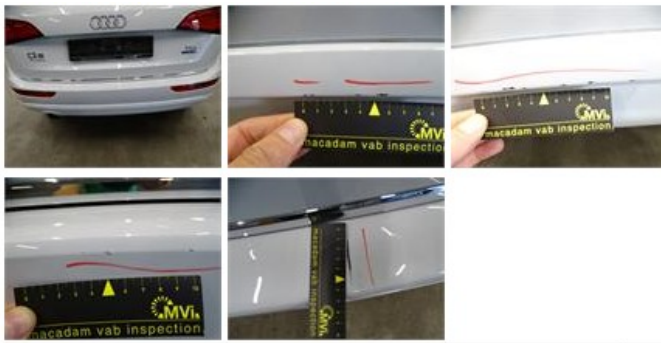
Bumper R, Scratch(es), LI - Repair and paint (complete)	254,16
--	---------------
