BMW 3: 1GTJ269

Limited Technical Inspection

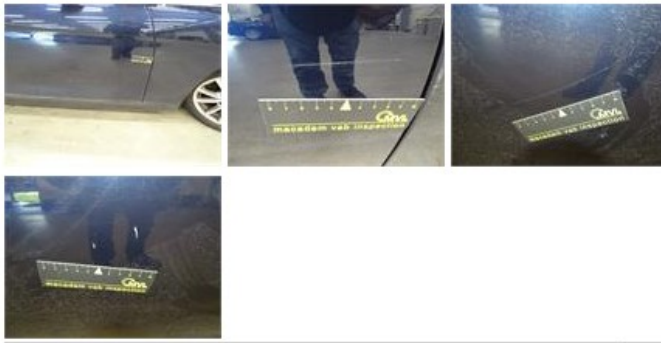
Compressor	Yes
Total cost ex VAT		1006,88
Certificate Of Conformity, Missing, E - Replace		150,00
<i>No pictures to display</i>		
Wing R R, Dent(s), Acceptable		0,00
<i>No pictures to display</i>		
Tailgate, Scratch(es), Acceptable		0,00
<i>No pictures to display</i>		
Bumper R, Scratch(es), Acceptable		0,00
<i>No pictures to display</i>		
Door F R, Scratch(es), LI - Repair and paint (complete)		318,35

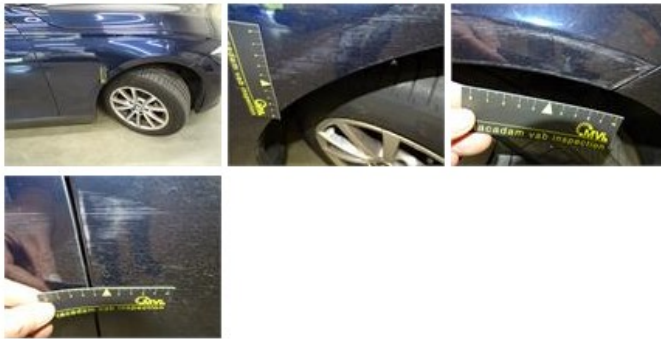
Wing F R, Scratch(es), LI - Repair and paint (complete) 220,18
