CITROEN C4 Picasso: 1FJK050

Limited Technical Inspection

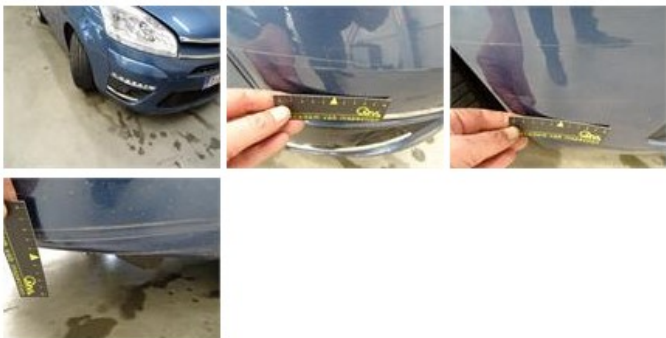
Roof, Dent(s), Acceptable		0,00
<i>No pictures to display</i>		
Front bumper, Scratch(es), LI - Repair and paint (complete)		211,80
