MITSUBISHI Outlander: 1GKX611			
Vinnnumber:	JMBXDGG2WEZ009489	Versionname:	OUTLANDER 4WD PHEV 121PK Aut.
First Registrationdate:	6/03/2014	Fiscalpower:	
Expertise Mileage:	151297	Power Kw:	89
Bodytype:	SUV	Body color:	Black
Gearbox:	Automatic	Paint type:	Metalic
Transmission:	4 Weel	Rims summer:	Aluminium
Fueltype:	Hybrid Petrol	Oil level:	OK
Battery functioning:	Yes	Parking lot:	4425
Number of doors:	5		
Number of seats:	5		
Number head rests:	5		
Rims summer:	Aluminium		
Category:	Passenger Car		
Oil level:	OK		
Registration Certificate Car (BE):	Yes

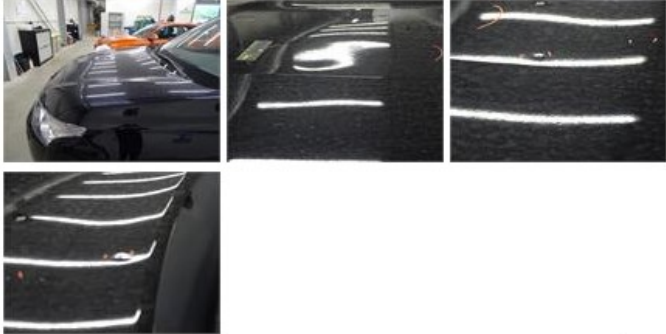
Front bumper, Scratch(es), Acceptable	0,00
<i>No pictures to display</i>	
Bumper R, Scratch(es), Acceptable	0,00
<i>No pictures to display</i>	
Bonnet, Dent(s), LI - Repair and paint (complete)	348,09

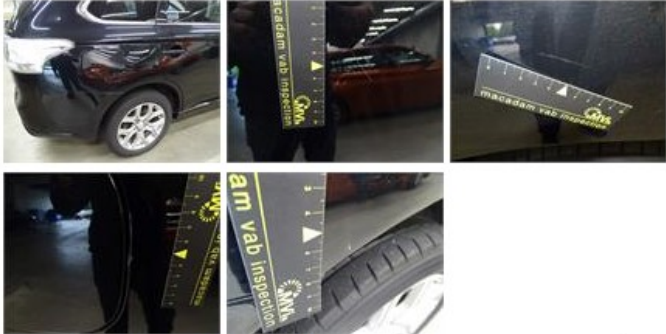
Wing R R, Scratch(es), LI - Repair and paint (complete)	369,84
