SKODA Octavia: 1HNU877

Limited Technical Inspection

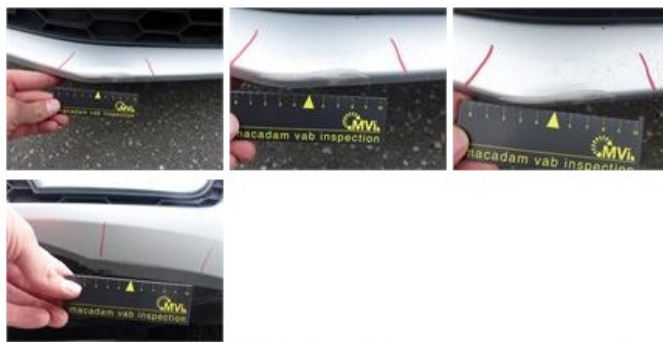
Front bumper, Dent(s) and scratch(es), LI - Repair and paint (complete)	235,80
---	---------------

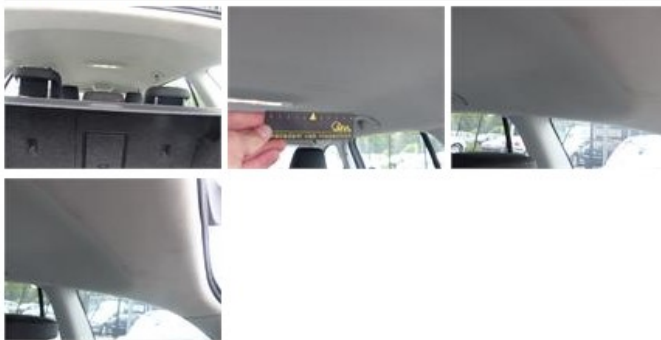
Rear bulkhead lining, Scratch(es), Acceptable	0,00
<i>No pictures to display</i>	
Bonnet, Stone chip(s), Acceptable	0,00
<i>No pictures to display</i>	
Alloy rim F R, Scratch(es), Acceptable	0,00
<i>No pictures to display</i>	
Wing R R, Scratch(es), Acceptable	0,00
<i>No pictures to display</i>	
Floor covering F L, Burned, Acceptable	0,00
<i>No pictures to display</i>	
Ceiling, Stain, Cleaning	25,00

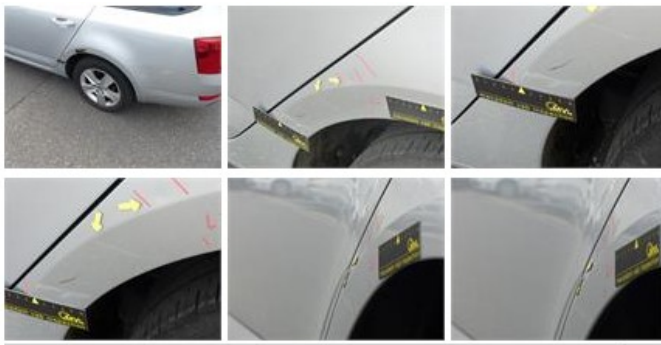
Tailgate, Scratch(es), Acceptable	0,00
<i>No pictures to display</i>	
Door panel R R, Scratch(es), Acceptable	0,00
<i>No pictures to display</i>	
Bumper R, Dent(s) and scratch(es), Acceptable	0,00
<i>No pictures to display</i>	
Internal Boot Lining R, Scratch(es), Acceptable	0,00
<i>No pictures to display</i>	
Door frame R L, Dent(s), Acceptable	0,00
<i>No pictures to display</i>	
Bumper grille, Scratch(es), Acceptable	0,00
<i>No pictures to display</i>	
Windscreen, Stone chip(s), Acceptable	0,00
<i>No pictures to display</i>	
Door R L, Dent(s) and scratch(es), Acceptable	0,00
<i>No pictures to display</i>	
Trunk lid covering R, Scratch(es), Acceptable	0,00
<i>No pictures to display</i>	
Sill trim R R, Scratch(es), Acceptable	0,00
<i>No pictures to display</i>	
Door F L, Dent(s) and scratch(es), Acceptable	0,00
<i>No pictures to display</i>	
Wing R L, Dent(s) and scratch(es), LI - Repair and paint (complete)	332,20
