VOLKSWAGEN Passat: 1FLJ277

Limited Technical Inspection

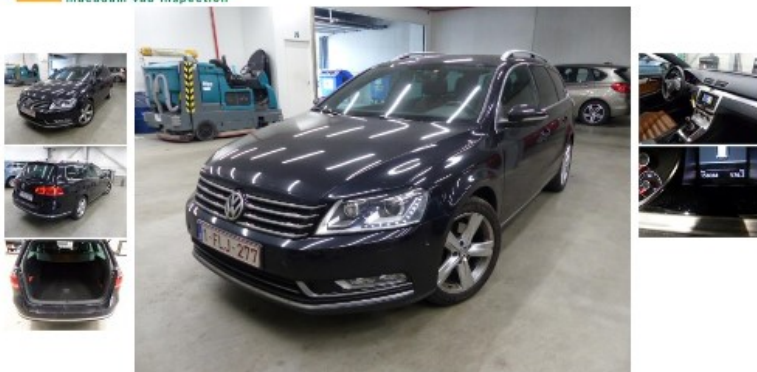
Vinnnumber:	WVWZZZ3CZEE005667	Versionname:	PASSAT VAR Highline 136PK
First Registrationdate:	6/08/2013	Fiscalpower:	
Expertise Mileage:	158084	Power Kw:	100
Bodytype:		Body color:	Black
Gearbox:	MAN 6 VIT	Paint type:	Metalic
Transmission:	Front	Rims summer:	Aluminium
Fueltype:	Diesel	Oil level:	OK
Battery functioning:	Yes	Parking lot:	3414
Number of doors:	5		
Number of seats:	5		
Number head rests:	5		
Rims summer:	Aluminium		
Category:	Passenger Car		
Oil level:	OK
