VOLKSWAGEN Touran: 1HAB058

Limited Technical Inspection

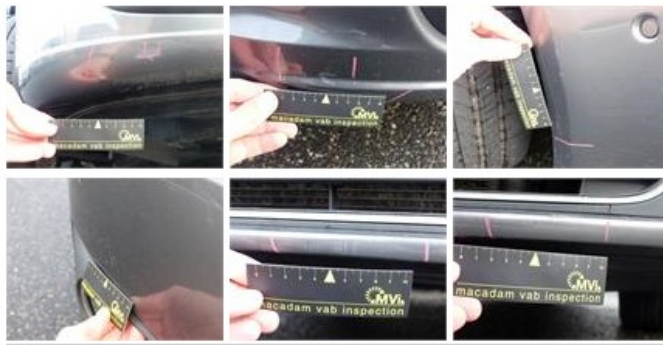
Front bumper, Scratch(es), LI - Repair and paint (complete) 235,80
