AUDI A6: 1FBT902

Limited Technical Inspection

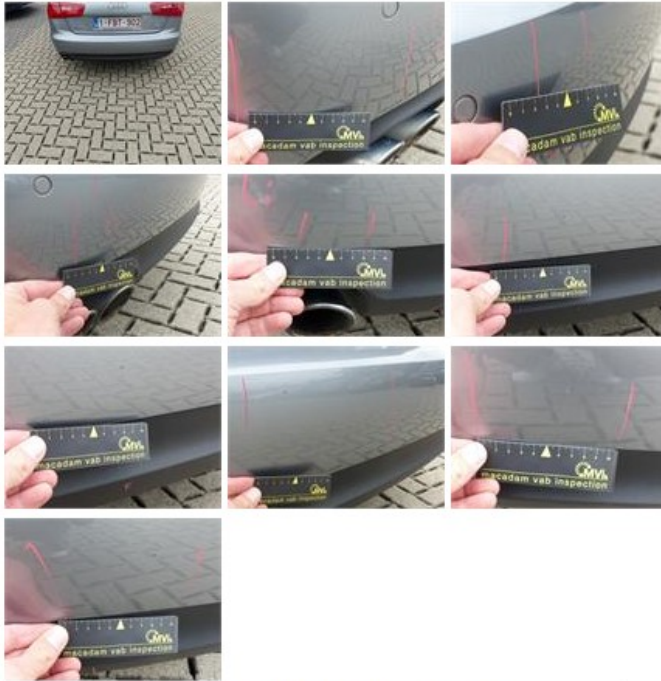
Roof, Rust, Acceptable	0,00
<i>No pictures to display</i>	
Alloy rim F R, Scratch(es), Acceptable	0,00
<i>No pictures to display</i>	
Wing R R, Dent(s) and scratch(es), Acceptable	0,00
<i>No pictures to display</i>	
Tailgate, Scratch(es), Acceptable	0,00
<i>No pictures to display</i>	
Alloy rim R R, Scratch(es), Acceptable	0,00
<i>No pictures to display</i>	
Bumper R, Dent(s) and scratch(es), LI - Repair and paint (complete)	278,16

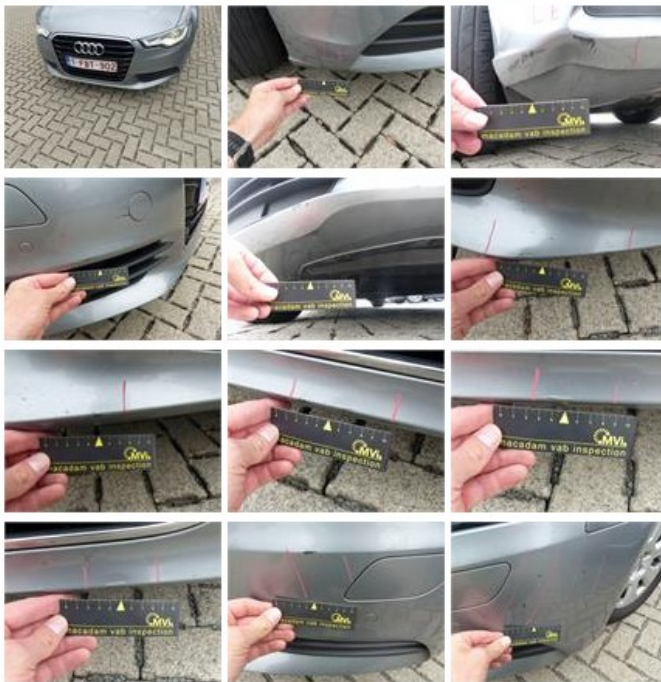
Front bumper, Dent(s) and scratch(es), Le - Replace and paint	862,80
---	--------
