<b>LU Mercedes gla: GZ4678</b>			
Vinnumber:	<b>WDC1569081J301066</b>	Versionname:	<b>GLA 200 d Style</b>
First Registrationdate:	<b>31/10/2016</b>	Fiscalpower:	
Expertise Mileage:	<b>74673</b>	Power Kw:	<b>100</b>
Bodytype:		Body color	<b>Black</b>
Gearbox:	<b>MAN 6 VIT</b>	Paint type	<b>Metalic</b>
Transmission:		Rims summer	<b>Aluminium</b>
Fueltype:	<b>Diesel</b>	Oil level	<b>OK</b>
Battery functioning	<b>Yes</b>	Parking lot	<b>2704</b>
Number of doors	<b>5</b>		
Number of seats	<b>5</b>		
Number head rests	<b>5</b>		
Rims summer	<b>Aluminium</b>		
Category	<b>Passenger Car</b>		
Oil level	<b>OK</b>

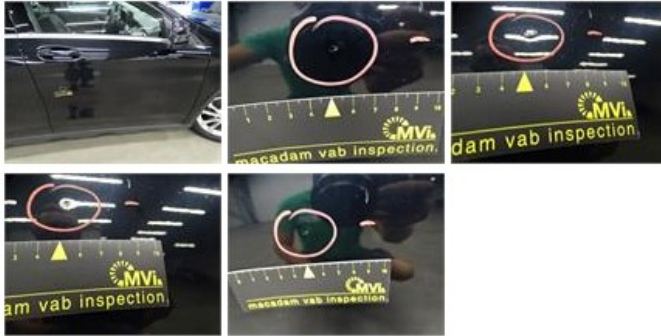
Bumper R, Scratch(es), Acceptable	0,00
<i>No pictures to display</i>	
Alloy rim F L, Scratch(es), Acceptable	0,00
<i>No pictures to display</i>	
Alloy rim R L, Scratch(es), Acceptable	0,00
<i>No pictures to display</i>	
Door F R, Dent(s) and scratch(es), LI - Repair and paint (complete)	382,02
