<b>SKODA Rapid: 1ETN228</b>			
Vinnnumber:	<b>TMBAL6NHXD4022678</b>	Versionname:	<b>RAPID BER Elegance GreenTec 105PK</b>
First Registrationdate:	<b>18/03/2013</b>	Fiscalpower:	
Expertise Mileage:	<b>141039</b>	Power Kw:	<b>77</b>
Bodytype:	<b>Hatchback</b>	Body color:	<b>Black</b>
Gearbox:	<b>MAN 5 VIT</b>	Paint type:	<b>Metalic</b>
Transmission:	<b>Front</b>	Rims summer:	<b>Aluminium</b>
Fueltype:	<b>Diesel</b>	Oil level:	<b>OK</b>
Battery functioning:	<b>Yes</b>	Parking lot:	<b>4707</b>
Number of doors:	<b>5</b>		
Number of seats:	<b>5</b>		
Number head rests:	<b>5</b>		
Rims summer:	<b>Aluminium</b>		
Category:	<b>Passenger Car</b>		
Oil level:	<b>OK</b>

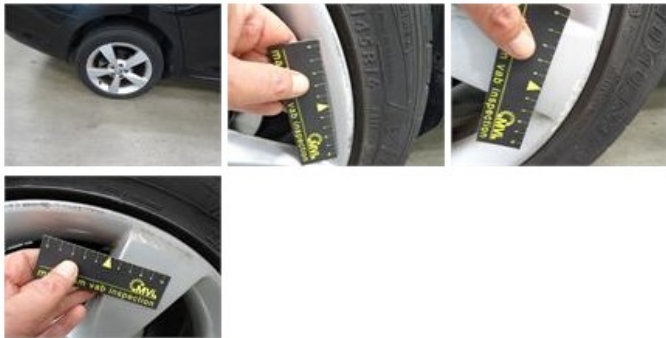
Total cost ex VAT	943,50
Alloy rim R R, Scratch(es), LI - Repair and paint (complete)	95,00
