VOLVO V70: 1HNZ722			
Vinnnumber:	YV1BW31A1F1317774	Versionname:	V70 D3 Polar 136PK
First Registrationdate:	2/09/2014	Fiscalpower:	
Expertise Mileage:	101920	Power Kw:	100
Bodytype:	Break	Body color:	Dark Blue
Gearbox:	MAN 6 VIT	Paint type:	Metalic
Transmission:	Front	Rims summer:	Aluminium
Fueltype:	Diesel	Oil level:	OK
Battery functioning:	Yes	Parking lot:	3307
Number of doors:	5		
Number of seats:	5		
Number head rests:	5		
Rims summer:	Aluminium		
Category:	Passenger Car		
Oil level:	OK		
Registration Certificate Car (BE):	Yes

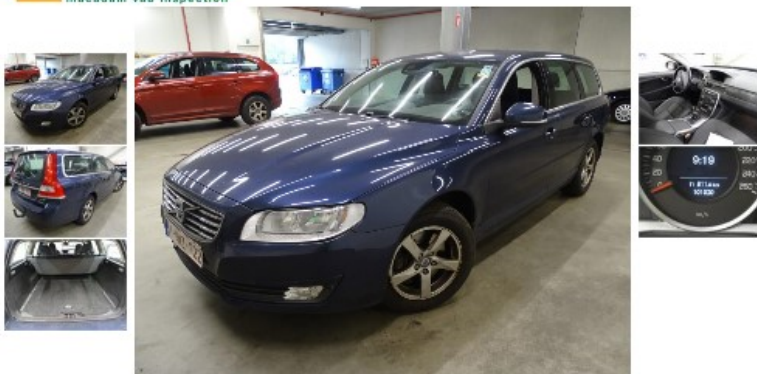
Assistance equipment			
Repair kit	Yes	Compressor	Yes
Total cost ex VAT			254,16
Roof, Chemical polution, LI - Repair and paint (complete)			0,00

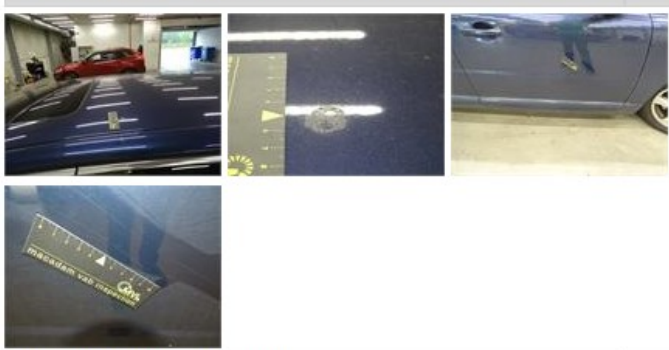
Door F R, Scratch(es), Acceptable	0,00
-----------------------------------	-------------
