VOLVO V60: 1LTJ750			
Vinnnumber:	YV1FW79C1G1310044	Versionname:	2.0 D3 KINETIC
First Registrationdate:	1/12/2015	Fiscalpower:	
Expertise Mileage:	95267	Power Kw:	110
Bodytype:	Break	Body color:	Grey
Gearbox:	MAN 6 VIT	Paint type:	Metalic
Transmission:		Rims summer:	Aluminium
Fueltype:	Diesel	Oil level:	OK
Battery functioning:	Yes	Parking lot:	2201
Number of doors:	5		
Number of seats:	5		
Number head rests:	5		
Rims summer:	Aluminium		
Category:	Passenger Car		
Oil level:	OK		
Registration Certificate Car (BE):	Yes

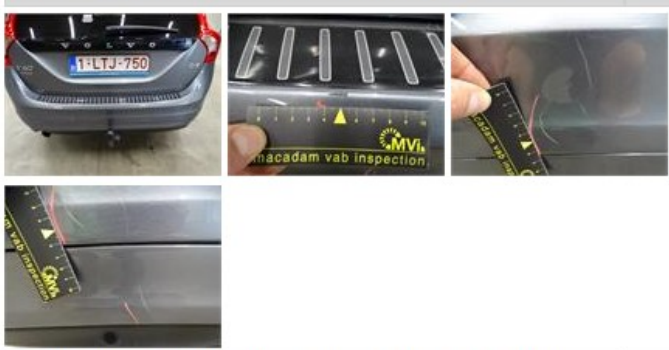
Assistance equipment			
Emergency spare wheel	Yes	Jack	Yes
Total cost ex VAT			931,95
Bumper R, Scratch(es), LI - Repair and paint (complete)			211,80
