RENAULT Scenic: 1GXY493

Limited Technical Inspection

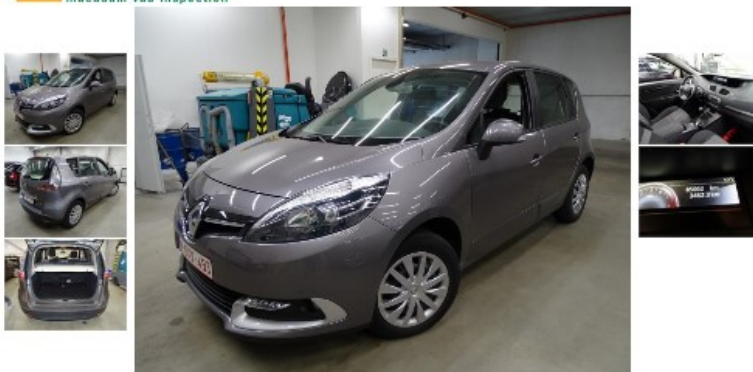
Vinnumber:	VF1JZ14K650902479	Versionname:	SCENIC Business 110PK
First Registrationdate:	2/06/2014	Fiscalpower:	
Expertise Mileage:	85002	Power Kw:	81
Bodytype:	Hatchback	Body color:	Grey
Gearbox:	MAN 6 VIT	Paint type:	Metalic
Transmission:	Front	Rims summer:	Steel
Fueltype:	Diesel	Oil level:	OK
Maintenance:	OK	Parking lot:	4227
Battery functioning:	Yes		
Number of doors:	5		
Number of seats:	5		
Number head rests:	5		
Rims summer:	Steel		
Category:	Passenger Car		
Oil level:	OK		
Registration Certificate Car (BE):	Yes

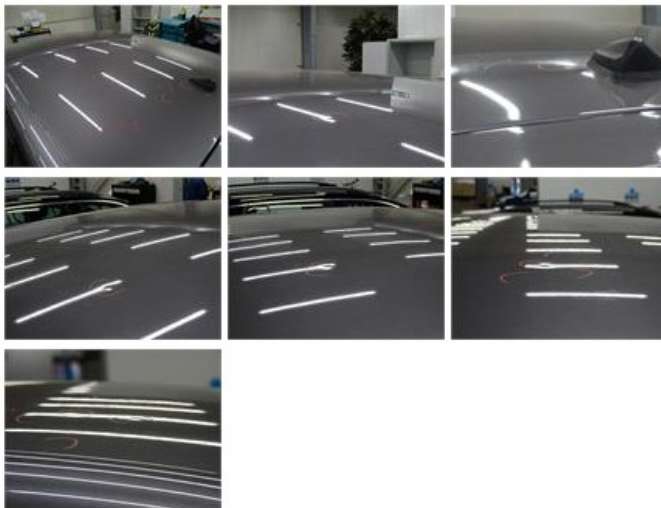
Roof, Hail damage, PDR - Hail 775,00
