MERCEDES Sprinter 300: 1EXR505

Limited Technical Inspection

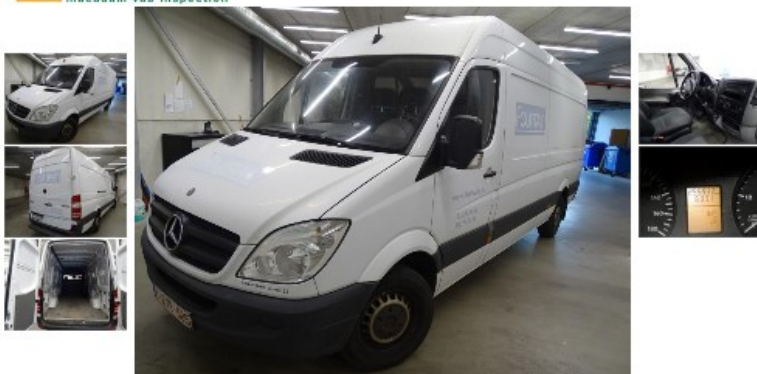
Vinnnumber:	WDB90663515787572	Versionname:	SPRINTER B/F 313 3500kg LWB HR 129PK
First Registrationdate:	16/04/2013	Fiscalpower:	
Expertise Mileage:	255932	Power Kw:	95
Bodytype:	Transporter	Body color:	White
Gearbox:	MAN 6 VIT	Paint type:	Opaque
Transmission:	Back	Rims summer:	Steel
Fueltype:	Diesel	Oil level:	OK
Battery functioning:	Yes	Parking lot:	LCV16
Number of doors:	5		
Number of seats:	3		
Number head rests:	3		
Rims summer:	Steel		
Category:	Light Commercial Vehicle		
Oil level:	OK
