OPEL Astra: 1FQM233

Limited Technical Inspection

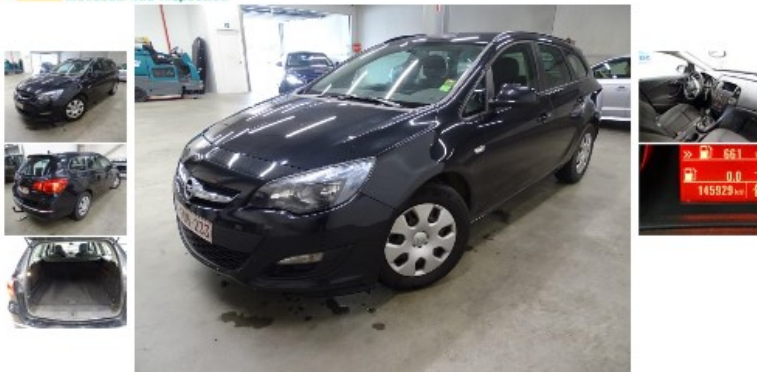
Vinnumber:	W0LPC8EW1E8007287	Versionname:	ASTRA BRE ecoFLEX Essentia S&S 110PK
First Registrationdate:	24/09/2013	Fiscalpower:	
Expertise Mileage:	145929	Power Kw:	81
Bodytype:	Break	Body color:	Black
Gearbox:	MAN 8 VIT	Paint type:	Metalic
Transmission:	Front	Rims summer:	Steel
Fueltype:	Diesel	Oil level:	OK
Battery functioning:	Yes	Parking lot:	4124
Number of doors:	5		
Number of seats:	5		
Number head rests:	5		
Rims summer:	Steel		
Category:	Passenger Car		
Oil level:	OK		
Registration Certificate Car (BE):	Yes
