VOLKSWAGEN Golf: 1HPX073			
Vinnumber:	WVWZZZAUZFP021416	Versionname:	GOLF BER Highline 150PK
First Registrationdate:	9/09/2014	Fiscalpower:	
Expertise Mileage:	80270	Power Kw:	110
Bodytype:		Body color:	Black
Gearbox:	MAN 6 VIT	Paint type:	Metalic
Transmission:	Front	Rims summer:	Aluminium
Fueltype:	Diesel	Oil level:	OK
Maintenance:	OK	Parking lot:	3512
Battery functioning:	Yes		
Number of doors:	5		
Number of seats:	5		
Number head rests:	5		
Rims summer:	Aluminium		
Category:	Passenger Car		
Oil level:	OK		
Registration Certificate Car (BE):	Yes

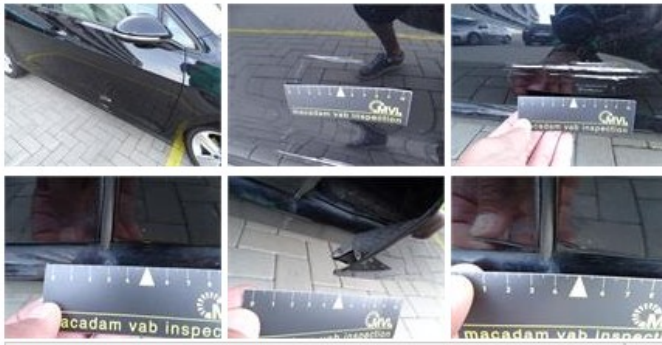
Wing R L, Scratch(es), Acceptable	0,00
<i>No pictures to display</i>	
Door F R, Dent(s) and scratch(es), LI - Repair and paint (complete)	318,35
