SKODA Octavia: 1GQV627			
Vinnumber:	TMBJG7NE5E0098897	Versionname:	OCTAVIA COMBI Ambition 105PK
First Registrationdate:	3/04/2014	Fiscalpower:	
Expertise Mileage:	175916	Power Kw:	77
Bodytype:	Break	Body color:	Beige
Gearbox:	MAN 5 VIT	Paint type:	Metalic
Transmission:		Rims summer:	Aluminium
Fueltype:	Diesel	Oil level:	OK
Battery functioning:	Yes	Parking lot:	1231
Number of doors:	5		
Number of seats:	5		
Number head rests:	5		
Rims summer:	Aluminium		
Category:	Passenger Car		
Oil level:	OK		
Registration Certificate Car (BE):	Yes

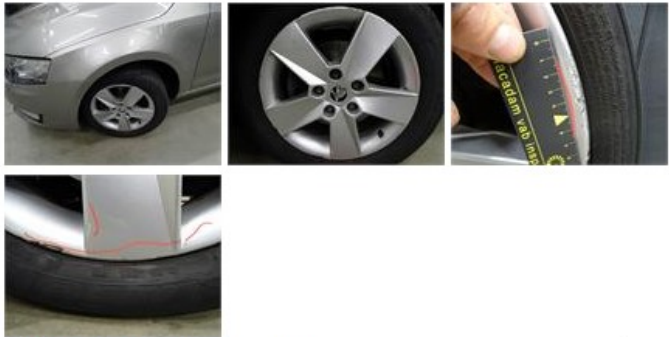
Assistance equipment			
Emergency spare wheel	Yes	Jack	Yes
Total cost ex VAT			653,80
Alloy rim F L, Scratch(es), LI - Repair and paint (complete)			95,00

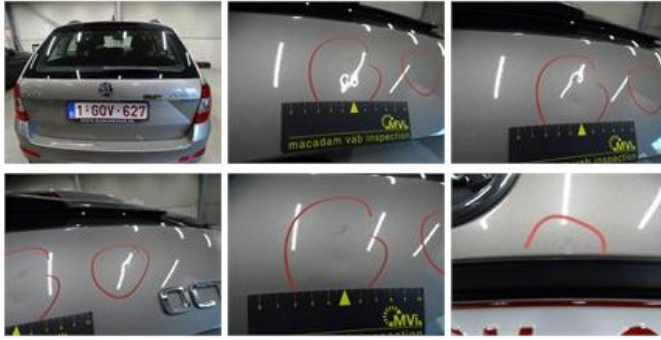
Tailgate, Dent(s) and scratch(es), LI - Repair and paint (complete)
