**SKODA Octavia: 1HLF959**

**Limited Technical Inspection**

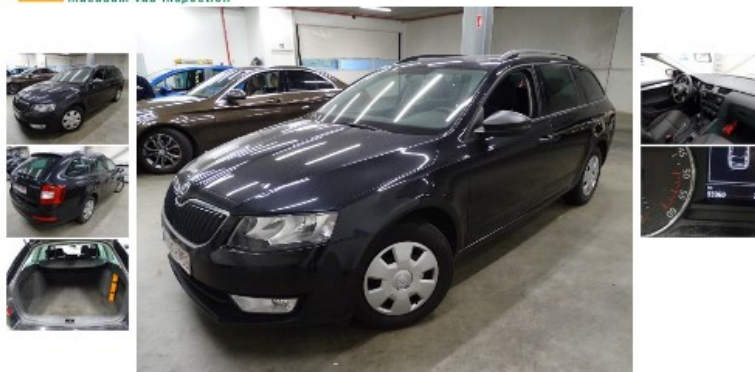
Vinnnumber:	<b>TMBJF7NE6F0056596</b>	Versionname:	<b>OCTAVIA COMBI Active</b>
First Registrationdate:	<b>19/08/2014</b>	Fiscalpower:	<b>90PK</b>
Expertise Mileage:	<b>93360</b>	Power Kw:	<b>66</b>
Bodytype:	<b>Break</b>	Body color:	<b>Black</b>
Gearbox:	<b>MAN 5 VIT</b>	Paint type:	<b>Metalic</b>
Transmission:	<b>Front</b>	Rims summer:	<b>Steel</b>
Fueltype:	<b>Diesel</b>	Oil level:	<b>OK</b>
Battery functioning:	<b>Yes</b>	Parking lot:	<b>4507</b>
Number of doors:	<b>5</b>		
Number of seats:	<b>5</b>		
Number head rests:	<b>5</b>		
Rims summer:	<b>Steel</b>		
Category:	<b>Passenger Car</b>		
Oil level:	<b>OK</b>		
Registration Certificate Car (BE):	<b>Yes</b>
