RENAULT Kangoo Express: 1EVN538

Vinnnumber:	VF1FW14BE48149533	Versionname:	KANGOO Expr. B/F Confort FAP (EU5) 75PK
First Registrationdate:	1/04/2013	Fiscalpower:	
Expertise Mileage:	128007	Power Kw:	55
Bodytype:	Transporter	Body color:	Black
Gearbox:	MAN 5 VIT	Paint type:	Metalic
Transmission:		Rims summer:	Aluminium
Fueltype:	Diesel	Oil level:	OK
Battery functioning:	Yes	Parking lot:	2308
Number of doors:	4		
Number of seats:	2		
Number head rests:	2		
Rims summer:	Aluminium		
Category:	Light Commercial Vehicle		
Oil level:	OK		
Registration Certificate Car (BE):	Yes

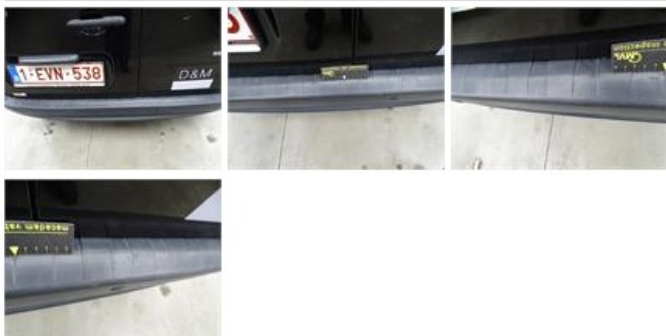
Total cost ex VAT:	941,70
Ignition key, Missing, E - Replace:	150,00
<i>No pictures to display</i>	
Trunk door R R, Scratch(es), Acceptable:	0,00
<i>No pictures to display</i>	
Bumper R, Deformed / Strained, E - Replace:	329,40
