RENAULT Clio: 1GUR673

Limited Technical Inspection

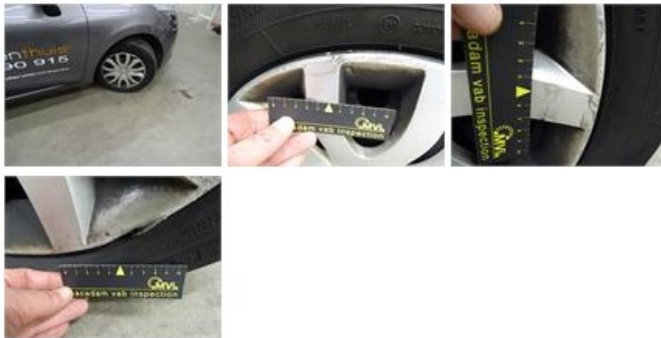
Wheel cover F R, Scratch(es), E - Replace 24,00
