AUDI A6: 1FBP113			
Vinnumber:	WAUZZZ4G7DN148046	Versionname:	TDI
First Registrationdate:	16/05/2013	Fiscalpower:	
Expertise Mileage:	151063	Power Kw:	100
Bodytype:		Body color:	Grey
Gearbox:	MAN 6 VIT	Paint type:	Metalic
Transmission:	Front	Rims summer:	Aluminium
Fueltype:	Diesel	Oil level:	OK
Battery functioning:	Yes	Parking lot:	3123
Number of doors:	5		
Number of seats:	5		
Number head rests:	5		
Rims summer:	Aluminium		
Category:	Passenger Car		
Oil level:	OK

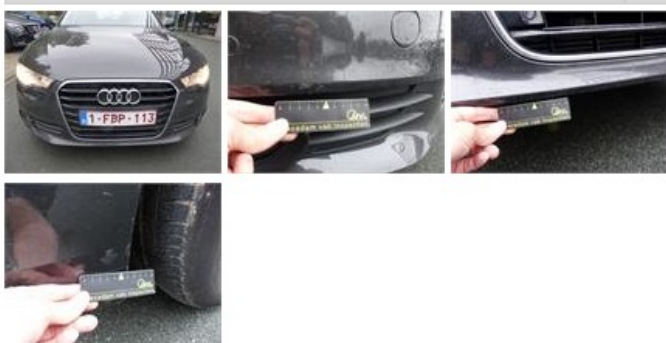
Assistance equipment			
Repair kit	Yes	Compressor	Yes
Total cost ex VAT			872,52
Bumper F, Scratch(es), LI - Repair and paint (complete)			254,16

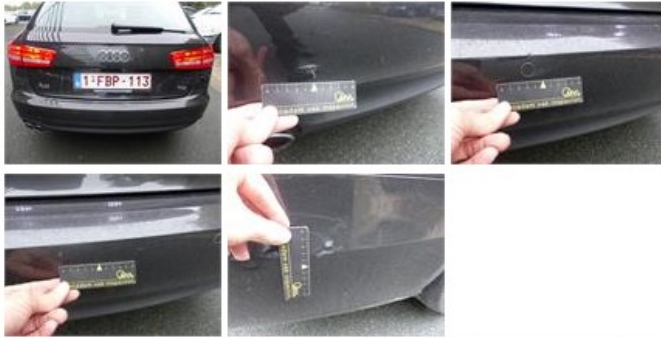
Bumper R, Dent(s) and scratch(es), LI - Repair and paint (complete) 302,16
